# MACHU PICCHU: PREHISTORIC SUSTAINABLE WATER SYSTEMS

By **Kenneth R. Wright, P.E. and  
Ruth M. Wright, J.D.**

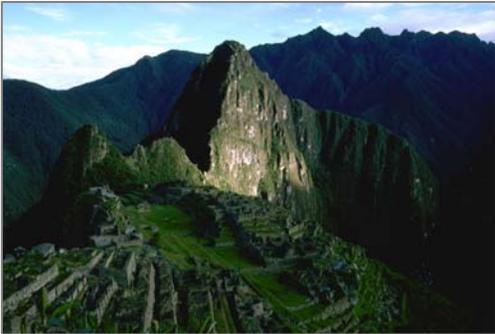
Established in A.D. 1450, Machu Picchu was the royal estate of the Inca Ruler Pachacuti. It is the essence of ancient sustainable design. The site is located 450 meters above the valley bottom on a mountain ridge between the prominent mountain peaks of Machu Picchu and Huayna Picchu. The site is a remarkable example of Inca ingenuity in the face of challenging natural topography and environment.

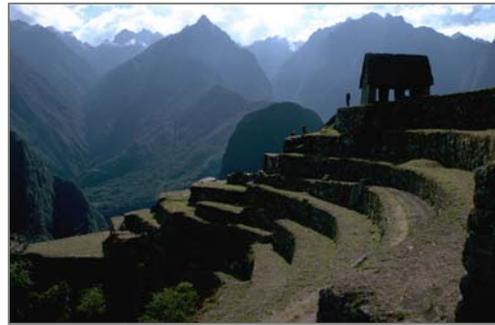
The well-preserved remains of Machu Picchu show that they had an advanced understanding of drainage and foundation design, the cornerstones of sustainability. Difficult site constraints existed at Machu Picchu associated with the nearly 2,000 millimeters per year of rainfall, steep slopes, landslides and remoteness.

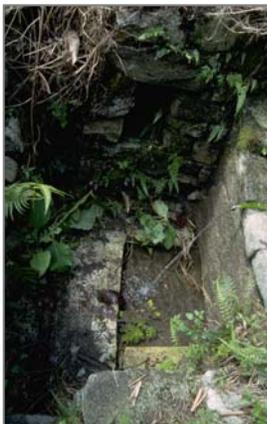
We conducted field investigations to define the agricultural drainage. The canal that furnished water to the fountains in the urban area of Machu Picchu traverses the agricultural sector, but there are no turnouts to the terraces. We also performed field investigations to determine whether surface drainage water was reused for irrigation purposes. No evidence of reuse of surface drainage for irrigation was found within the Machu Picchu ruin. Neither was the discharge from the domestic water supply fountains directly reused for irrigation, but merely discharged to the Main Drain. However, evidence was found which shows that subsurface drainage water was captured for several stone-formed fountains among the lower terraces downhill from Machu Picchu.

Our inspection of the terraces and the examination of photographs taken of Machu Picchu in 1912 by Hiram Bingham indicated little erosional evidence from surface runoff, even after nearly four centuries of no

maintenance and significant rainfall. The surface infiltration of rainfall to the subsoil drainage system was highly effective. The parallel surface drainage system for the agricultural terraces, for the most part, provided redundancy and a drainage safety factor for intense rainstorm events.
